**CLIENT:** American Frame Manufacturing  
7560 Bristow Ct. Unit B  
San Diego, CA, 92154  
Attn: Mario Riguer

**Test Report No: RJ1679-P**

**SUBJECT:** Structural Performance Testing on Decorative Stone Panels.

**SAMPLE ID:** Tongue and Groove, Decorative Stone Panels measuring approximately 24" x 48" x 1" thick.

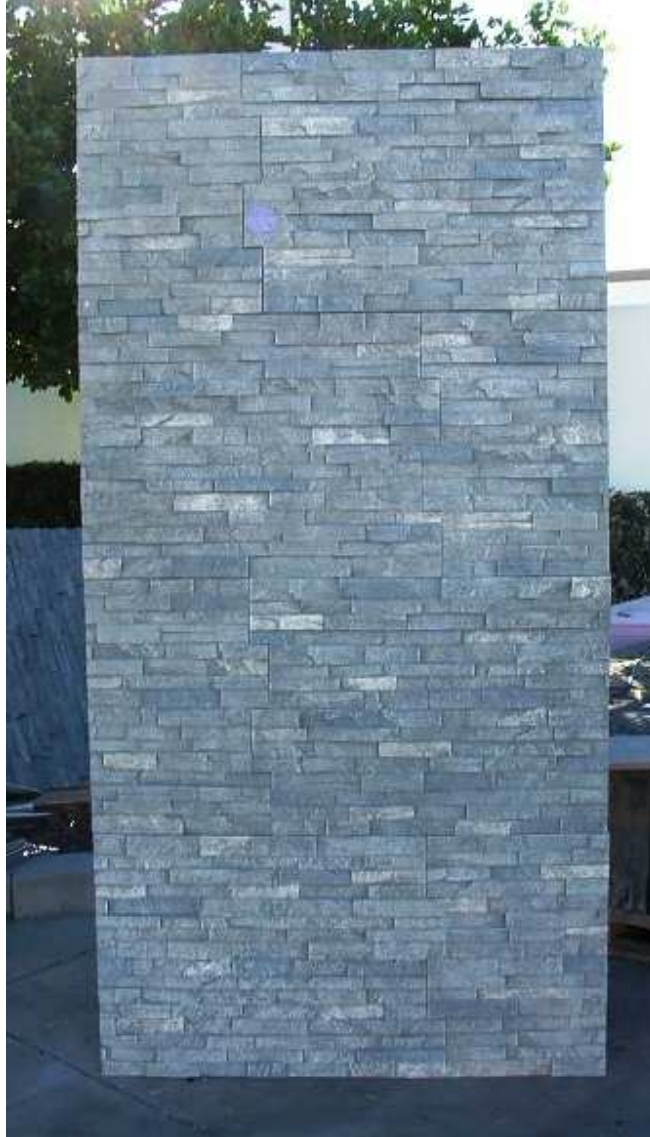
Photograph No.1  
Decorative Stone Test Panel

**Test Panel Construction:** Six 4' wide by 8' high test panels were constructed for the test. Each wall panel consisted of nominal 2 x 4, SPF, wood studs spaced 16 inches on center, <sup>15</sup>/<sub>32</sub>-inch thick, APA, OSB sheathing board, Tyvek<sup>®</sup> Housewrap weather resistive barrier and tongue and groove decorative stone panels.

The OSB sheathing was fastened to the wood framing with 6d galvanized nails spaced 6 inches on center around the perimeter and 12 inches on center in the field. The Tyvek<sup>®</sup> Housewrap was placed over the OSB sheathing and stapled into place. Four tongue and groove decorative stone panels were horizontally placed over the weather resistive barrier and fastened to the wood framing with 2½-inch long deck screws.

One screw was placed at the top, middle, and bottom of each foam panel approximately 11 inches on center at the edge of the framing. To simulate in field installation, each decorative panel was cut so that one tongue and groove joint was located over one stud 16 inches on center. The panels were installed in such a manner so that the joints were staggered from top to bottom in the wall assembly. One screw was located at each tongue, approximately 12 inches on center at each vertical joint, a minimum of 1-inch from each end of the tongue.

A total of three horizontal and four vertical joints were incorporated in each wall panel assembly. A total of 13 deck screws were used to secure one 24-inch by 48-inch decorative stone panel. A total of 52 deck screws were used to secure the foam panels to the framing which incorporated a 4' x 8' (32 sq.ft.) test area. The screws were placed directly through the exterior side of the foam panel and counter sunk approximately ⅛-inch. A photograph of the exterior side of the wall panel assembly is provided in the appendix of this report.

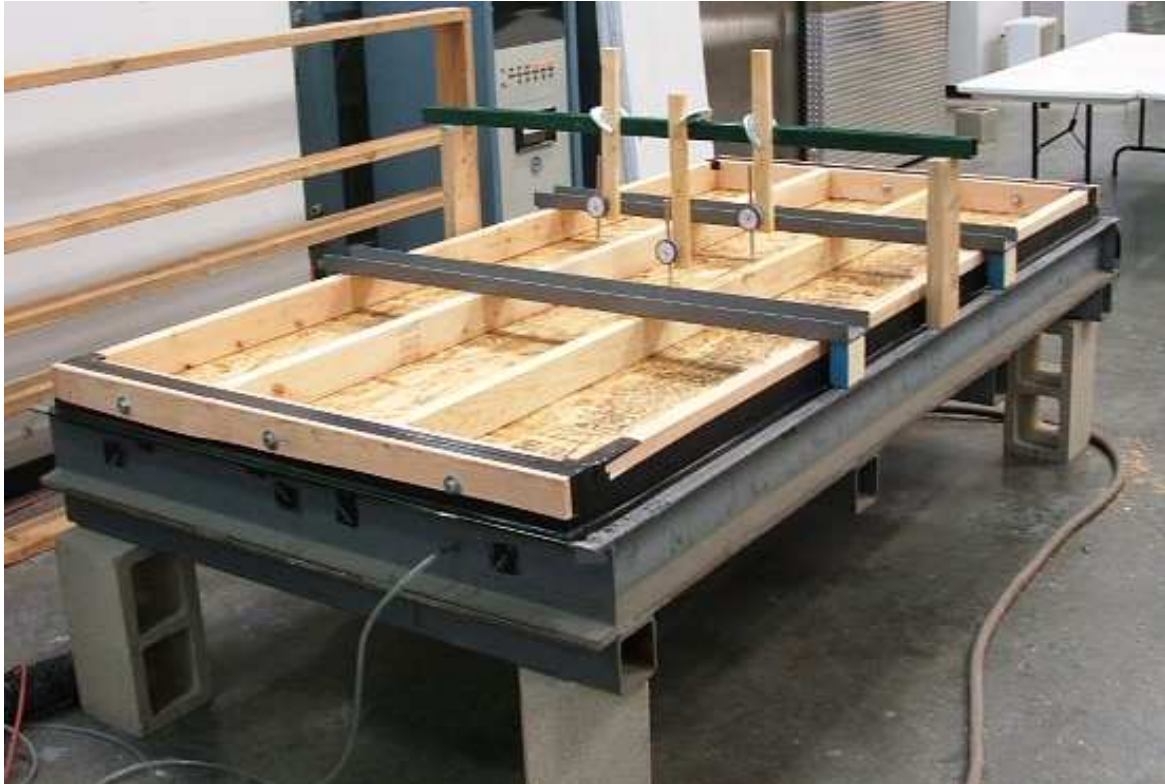
Photograph No.2  
Negative Load Test Set-Up

For negative load tests, the panels were individually placed horizontally, face down, on the test chamber and an airtight seal provided around the perimeter of the panel. To prevent failure in the framing, two, 6-inch wide steel "C" channels were attached across the back of the studs, approximately 32 inches apart. The loads were uniformly applied to the exterior side of the panel using a reversible controllable blower system.

A photograph of the negative load test set-up is provided in the appendix of this report.

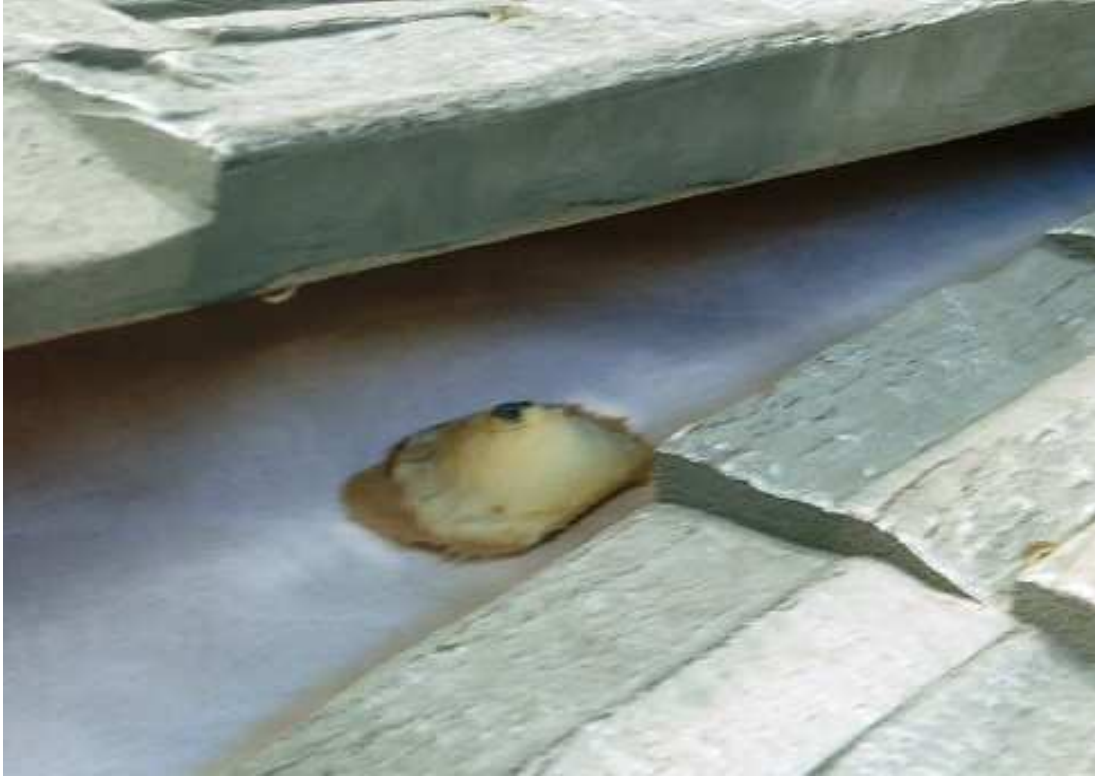
Photograph No.3  
Typical results of the negative load test  
Fasteners pulled through the foam panels

Panel #	Observations
1	At a test load of 109 psf, the heads of the deck screws pulled through the foam panels.
2	At a test load of 125 psf, the heads of the deck screws pulled through the foam panels.
3	At a test load of 109 psf, the heads of the deck screws pulled through the foam panels.
	<b>The average ultimate test load for the three panels is 114 psf.</b>

A photograph showing the typical mode of failure is provided in the appendix of this report.
